MEMOIRS OF THE  
ARCHAEOLOGICAL SURVEY OF INDIA  
No. 93

# EXCAVATIONS AT SANNATHI 1986 - 1989

J. R. HOWELL  
*WITH CONTRIBUTIONS FROM*  
G. V. S. RAO, J. V. P. RAO  
*and*  
ANNIE HOWELL

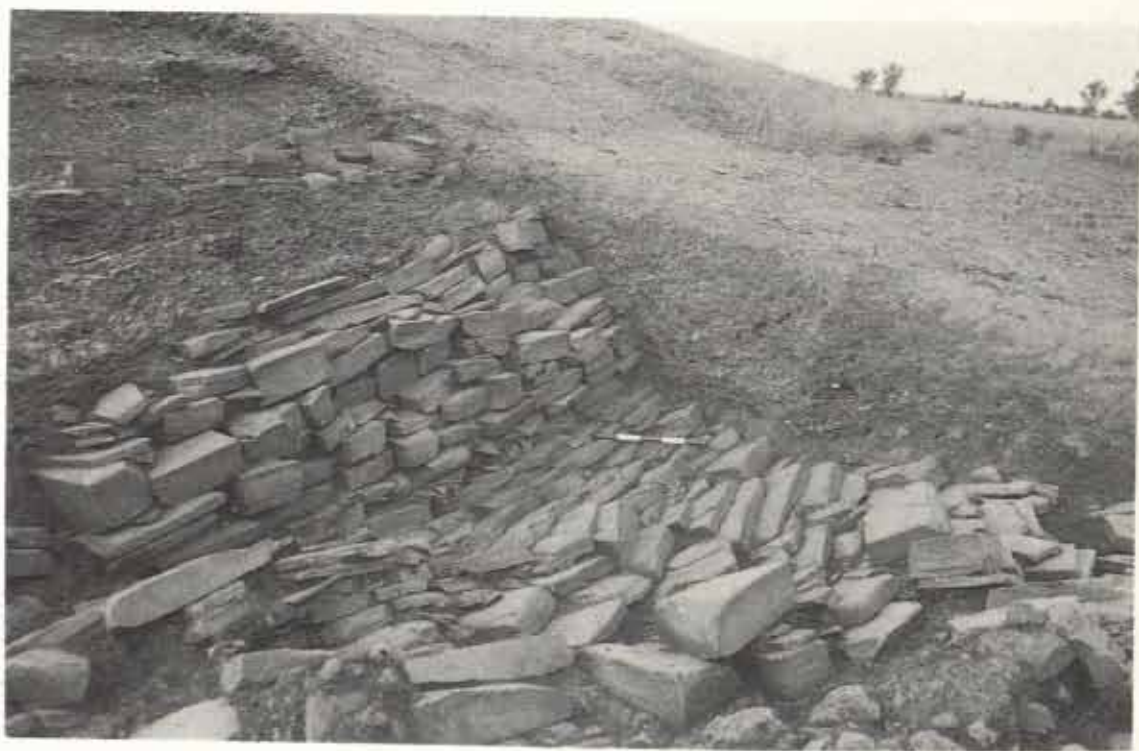
The earliest phase of construction at the mound is a stone revetment wall extending from the north cardinal point (pl. IVA), where it is sealed by the later brickwork, to the eastern cardinal point of the stupa (see fig. 6). Around its length it can be seen in various stages of disintegration. At the point where it is best preserved, twenty courses of stone work survive to a height of 1.60m. The stone blocks, from which it is constructed, vary in size and proportion, and hence there is no regular coursing, aside from the concentration of larger stones at the bottom of the wall. Although certain

*Stone revetment of mound: A, at north cardinal point and B, with later brick structure. See pp. 13 and 16*

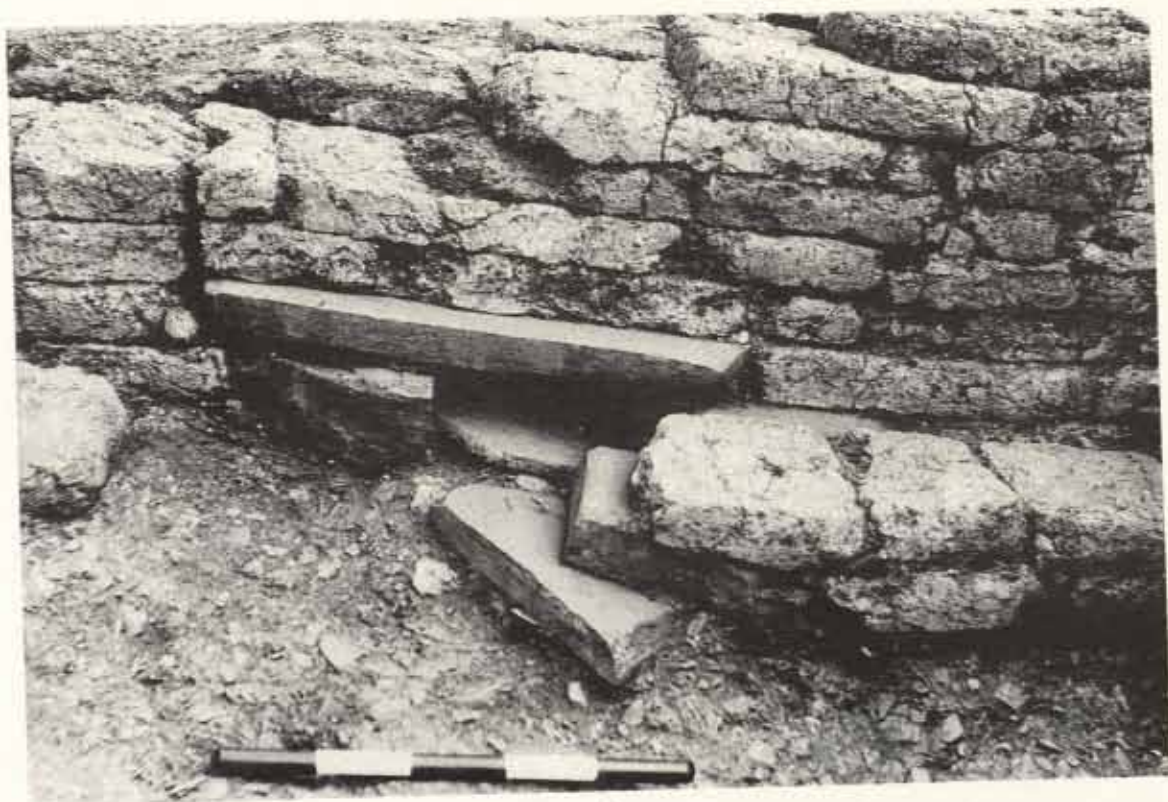
Based upon this evidence it is possible to reconstruct an area of tiles roofing, using the more complete tile fragments (pl. VII B). Successive courses of tiles, which may have been offset from one another, would overlies the lower course to such an extent to expose only the portion of the tile with the run off rills on it. From this reconstruction the exact area of tile that was exposed in a roof could be measured. This was found to be approximately  $140 \times 140$  mm or 0.0196 sq m. It was therefore calculated that the tile material from the two dumps, was sufficient to roof an area of 41 sq m. This figure represents the minimum area that could have been roofed, since it is possible that some of the tile from the disintegrated roof may not have been redeposited *in situ*.

A, drain ; B, reconstruction of a portion of tile roofing.  
See pp. 20 and 22

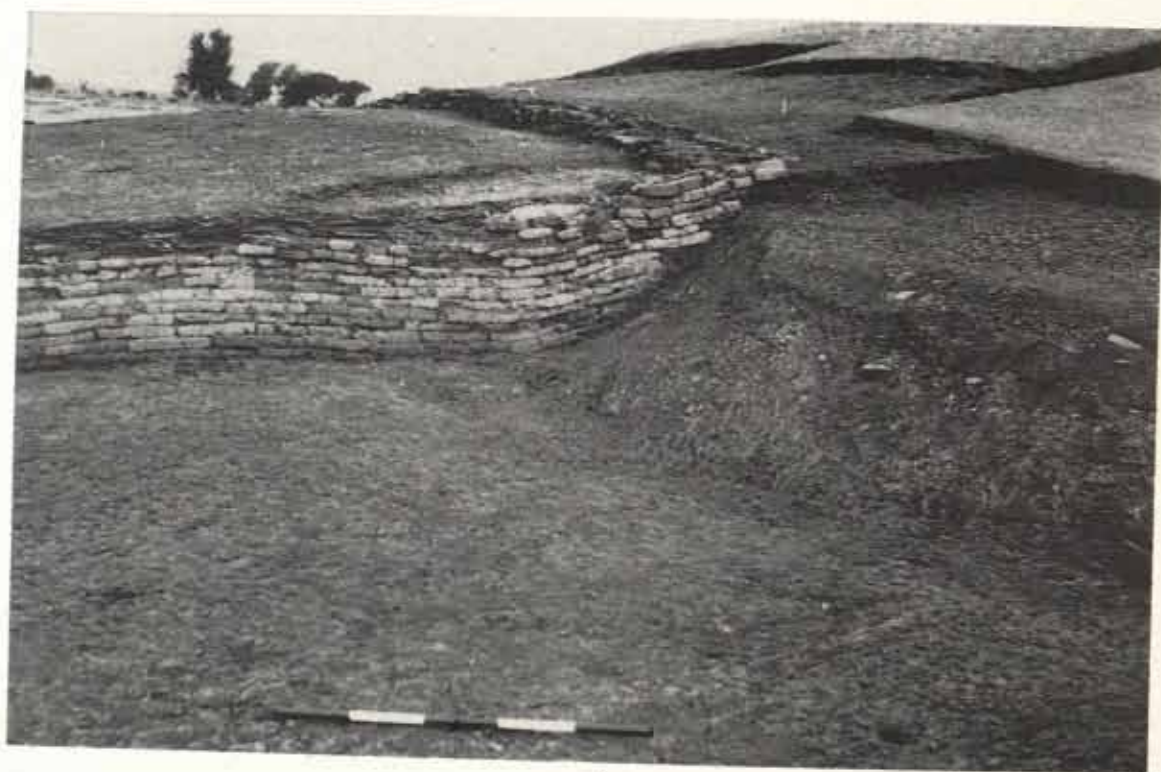
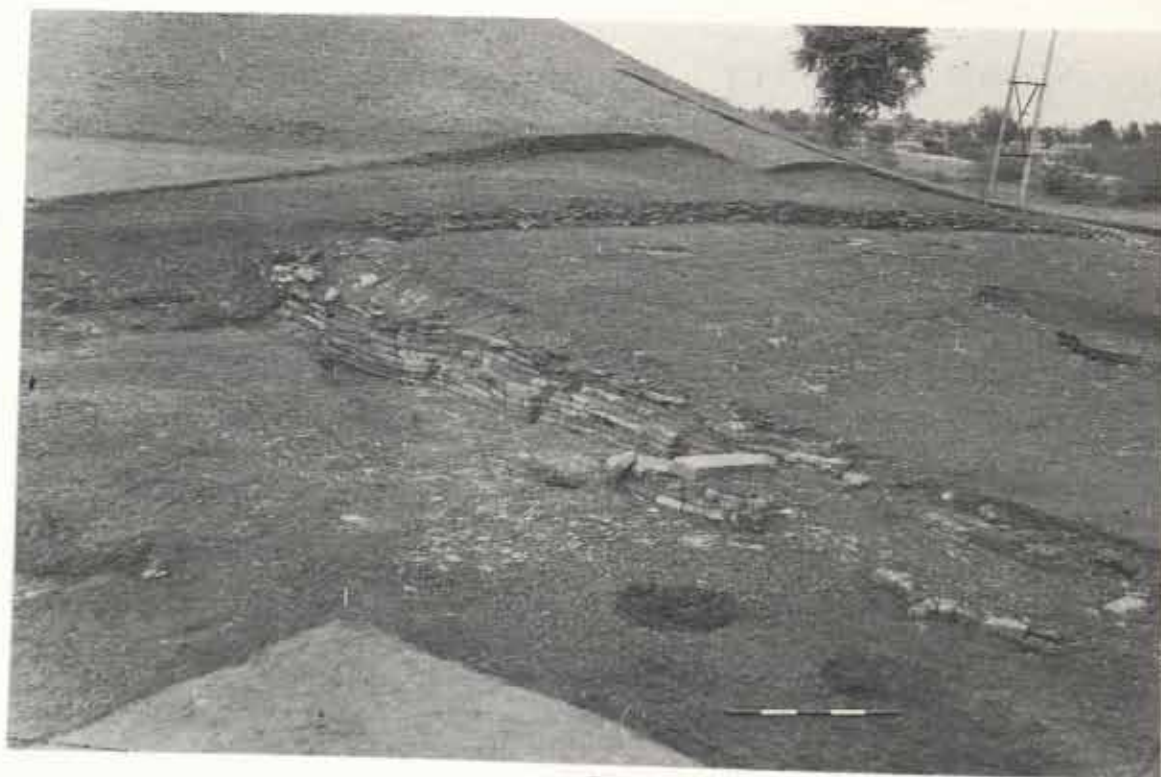
*Platform at south cardinal point : A, east wall and B, west wall. See p.22*

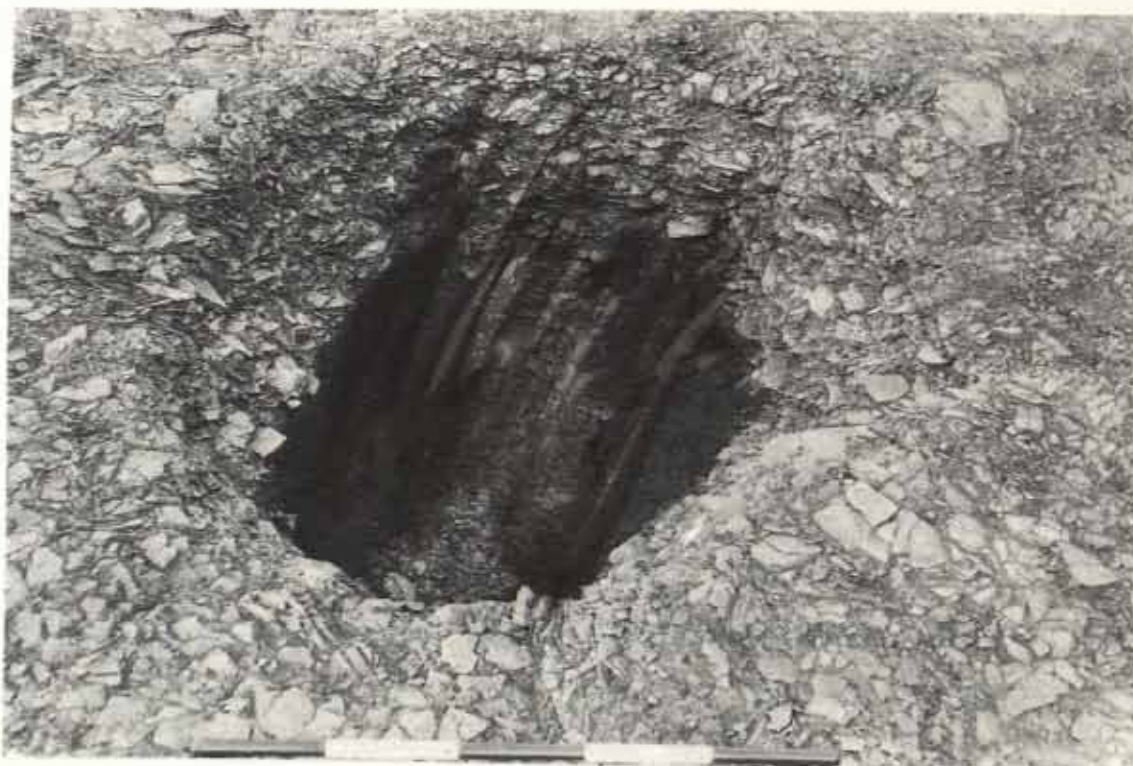
*Platform at south cardinal point : A, robbing cut for memorial slab  
and B, locations of memorial slabs. See p.23*

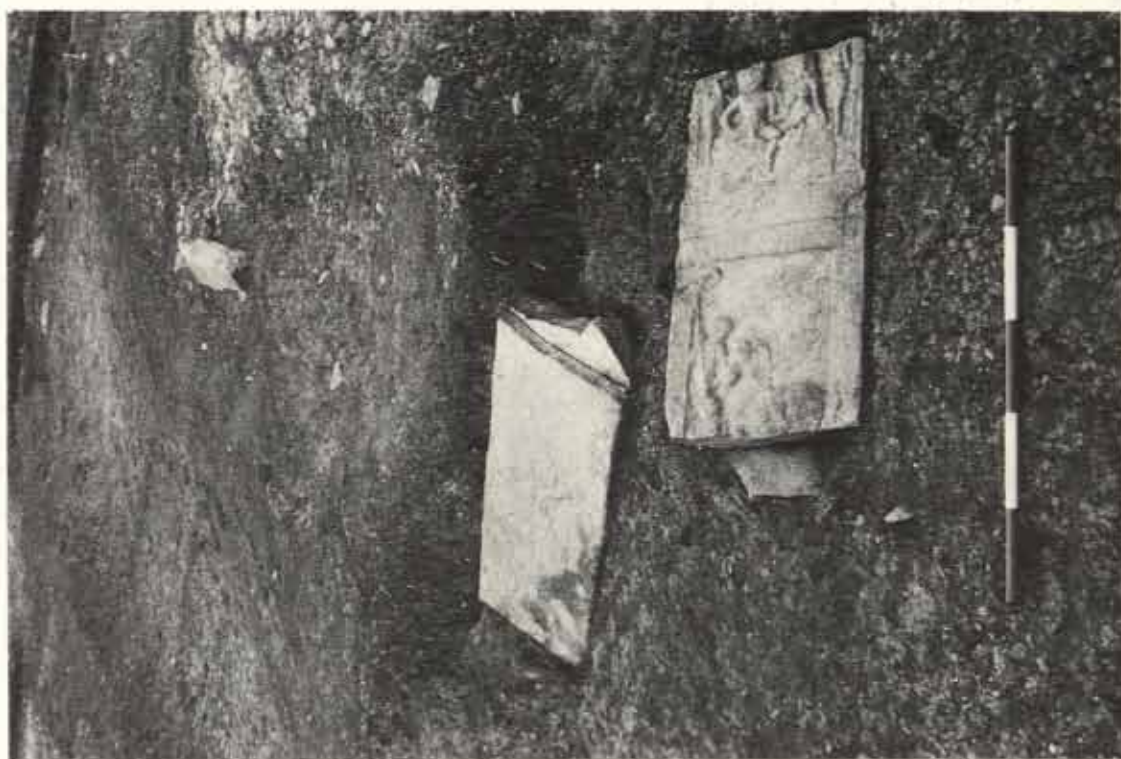
Around these foundations were another series of cut features (fig. 8, e). These were longitudinal cuts, with deeper circular sections at each end (pl. X B). They may represent double post-holes (pl. XI A) for some form of canopy over the assembly of memorial stones. A number of other cut features, and an area of densely packed bricks and stones were found round the edge of the platform (fig. 8, f). Although these were much smaller than the cuts in the centre, the ones at the back of the platform, where it survives to its greatest height, were found to be very deep. This again implies that whatever once stood at that point, was both heavy and tall.

*A, double post-holes; B, broken sculpture fragments around drum. See pp.23-24*
